| REPORT DOCUMENTATION PAGE | | READ INSTRUCTIONS BEFORE COMPLETING FORM |
|--|---|---|
| 4. TITLE (and Subtitle) Phase 1 Inspection Report Harrower Pond Dam (Inventory Number NY207) Mohawk River Basin, Montgomery County, New York. Inventory No. 207 | | 5. TYPE OF REPORT & PERIOD COVERED Phase 1 Inspection Report National Dam Safety Program |

26 SEP 1980

PHASE I INSPECTION REPORT
NATIONAL DAM SAFETY PROGRAM
HARROWER POND DAM I.D. NO. NY 207
DEC #189A-907 MOHAWK RIVER BASIN
MONTGOMERY COUNTY

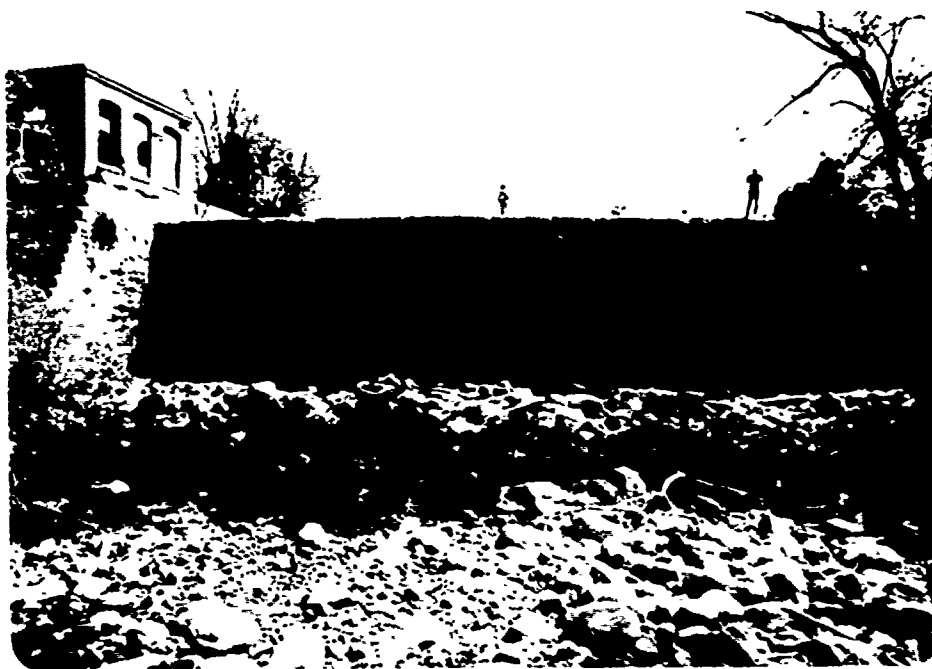
Photo #18
 Spillway Downstream Face
 Note Seepage (dark area) 5/28/80
